## A Record of the Australian Mirage Wing Fatigue Test

DSTO-TR-1561

A full-scale fatigue test was completed in August 1974 on a Mirage III0 starboard wing utilising a loading spectrum as specified by the Royal Australian Air Force (RAAF). To satisfy a variety of RAAF missions, twelve (12) servo-hydraulic actuators situated at critical locations on the wing reproduced the measured flight strains. The fatigue loading flight-by-flight sequence was derived from fatigue meter data that was obtained from the Mirage fleet and from continuous records from an instrumented Mirage in the squadron service. The conduct and results of this innovative test are summarised here.

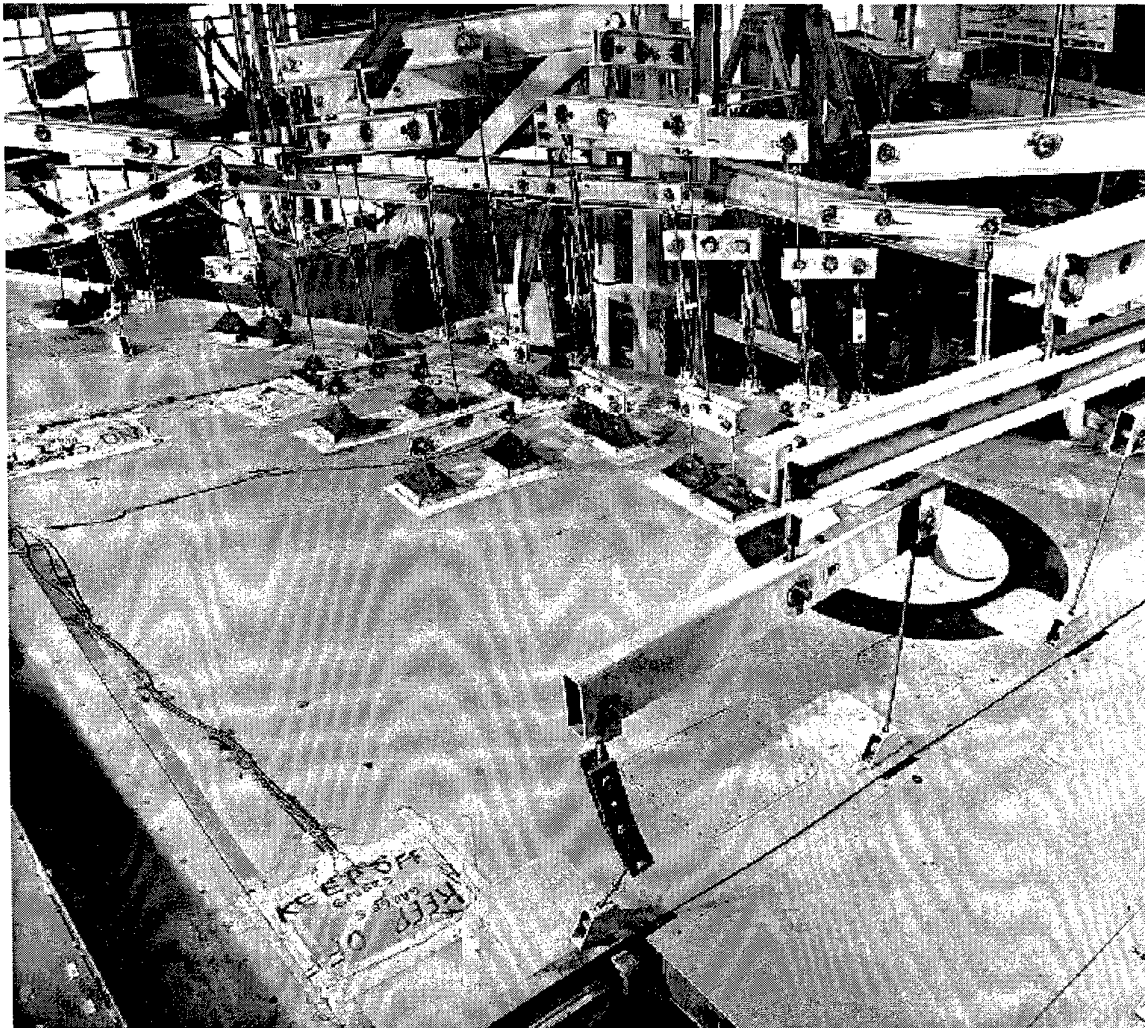
Figure 31: Wing Upper Surface Loading Pads
